## Ratcliffe Manor (Radcliffe Manor)

### **Architectural Survey File**

T-42  
Radcliffe Manor Dairy Complex  
7768 Radcliff Manor Road  
Easton Vicinity  
Ca. 1910-1940  
Private

# Maryland Historical Trust Maryland Inventory of Historic Properties Form

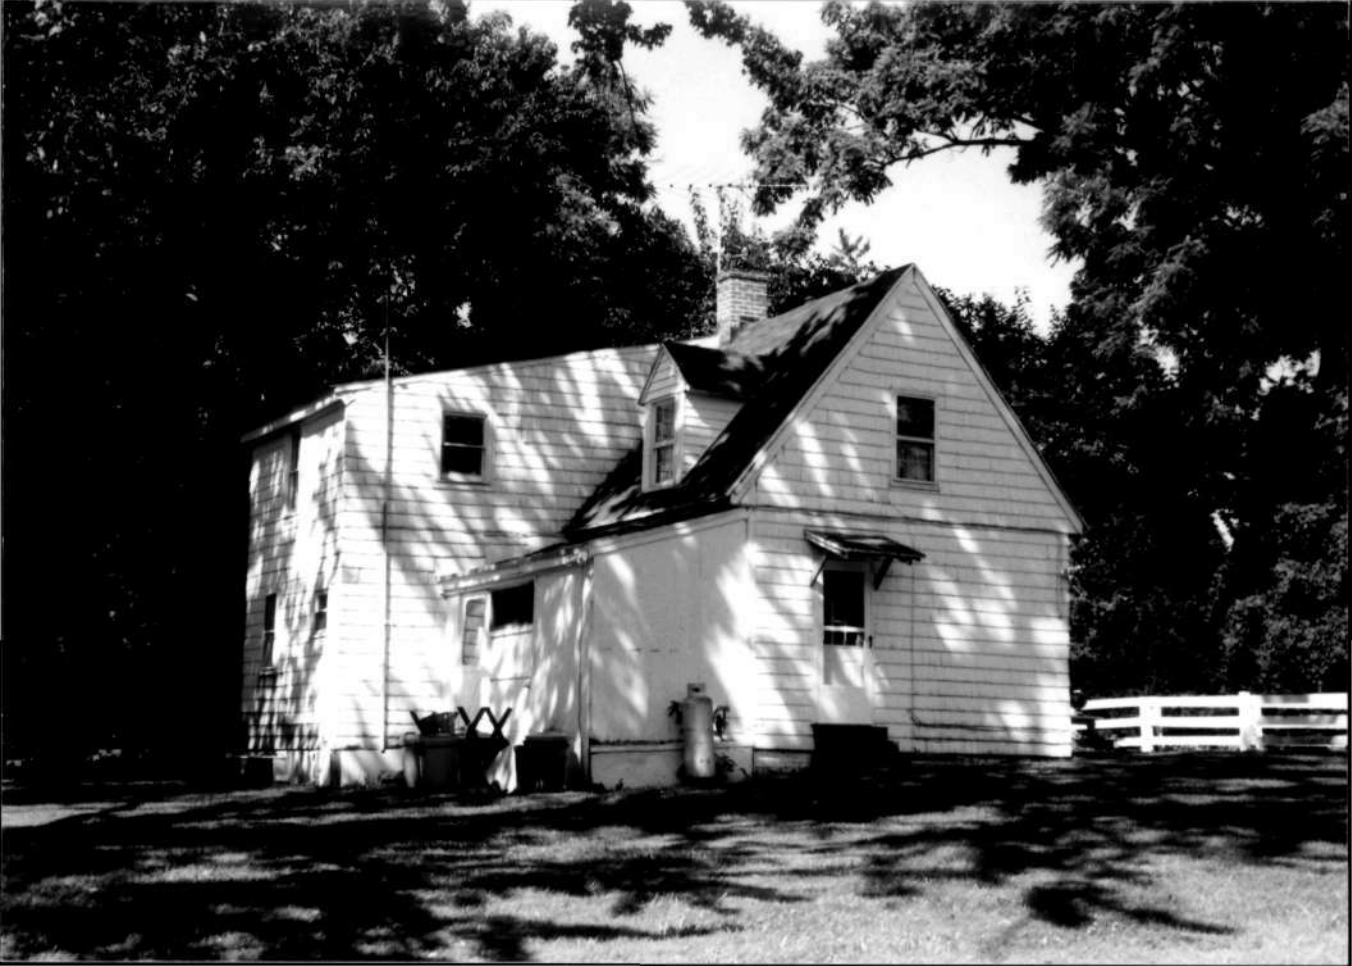
1/25

Tenant house looking SW

The ca. 1920 tenant house is located to the southwest of the dairy complex. The residence is a one-and-a-half story wood frame structure with a hall-parlor plan and a ca. 1960 two-story rear shed roof addition. The building rests on a continuous brick masonry foundation, with a continuous concrete masonry unit foundation on the rear addition. The building is clad with wood shingles. The side gable roof is clad with asphalt shingles and has three gable roof dormers. The central entry door is flanked by six-over-six wood sashes. The same windows are used on the ca. 1920 portion of the building. The ca. 1960 addition has one-over-one wood sashes. The building has a central brick masonry chimney. The rear porch has been enclosed with tongue and groove siding. The interior was not accessible at the time of the survey. To the east of the milk house, within a fenced enclosure, is a poured concrete silo on a poured concrete pad. The silo has a conical roof clad with standing-seam metal. An enclosed metal ladder is located on the west façade. Just to the east, outside of the enclosure is a timber frame fodder shed with an open east façade. The shed rests on a combination pier and continuous poured concrete foundation. The walls are clad with board and batten siding. The side gable roof is clad with asphalt shingles. There are no doors or windows. The interior of the building is unfinished with an earthen floor.

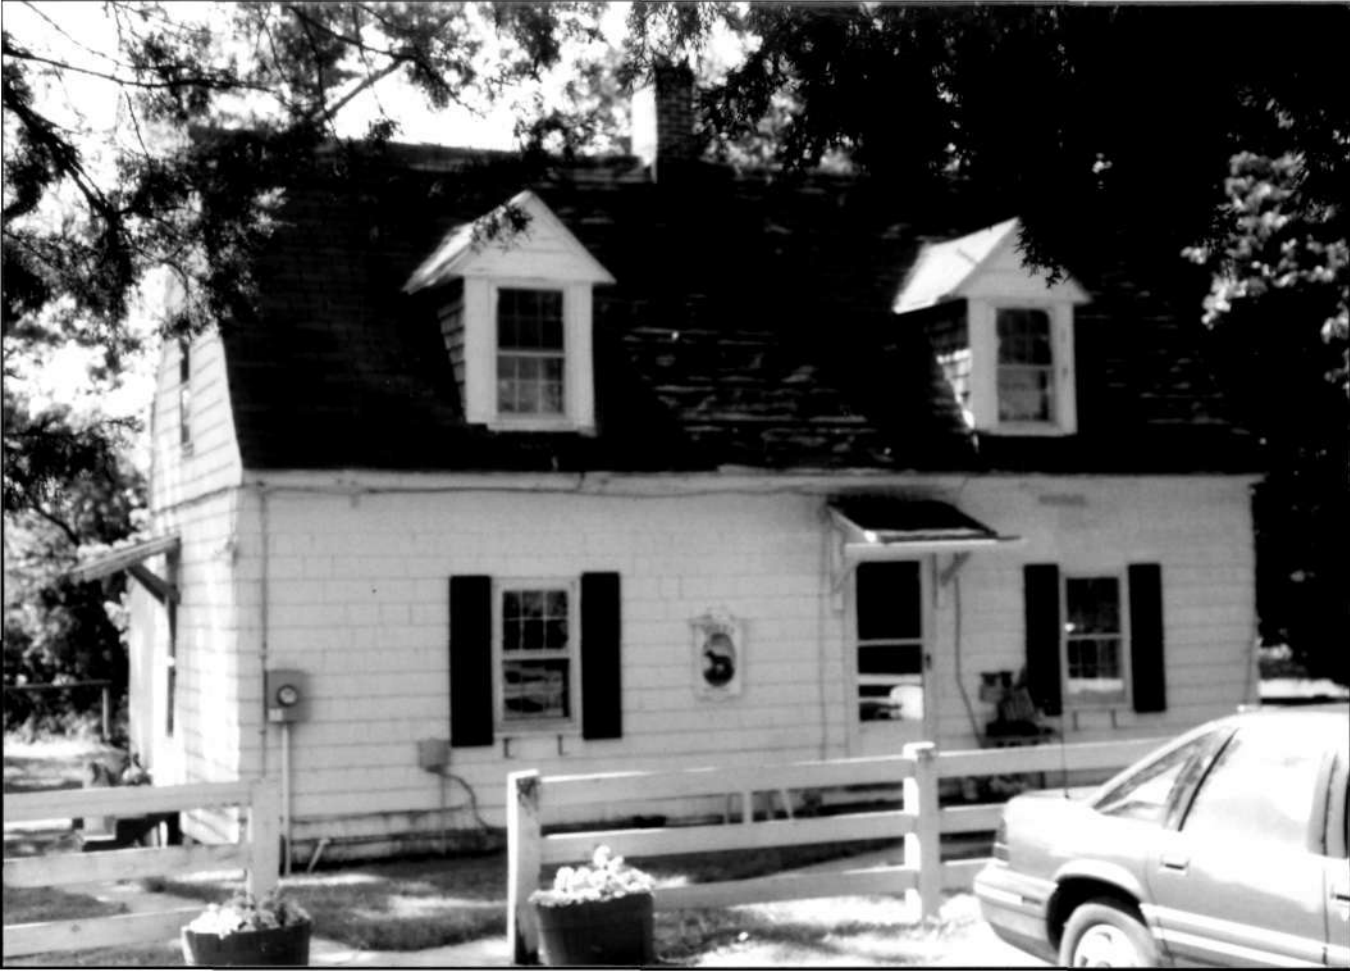
2/25

Tenant House, Front facade Looking S.

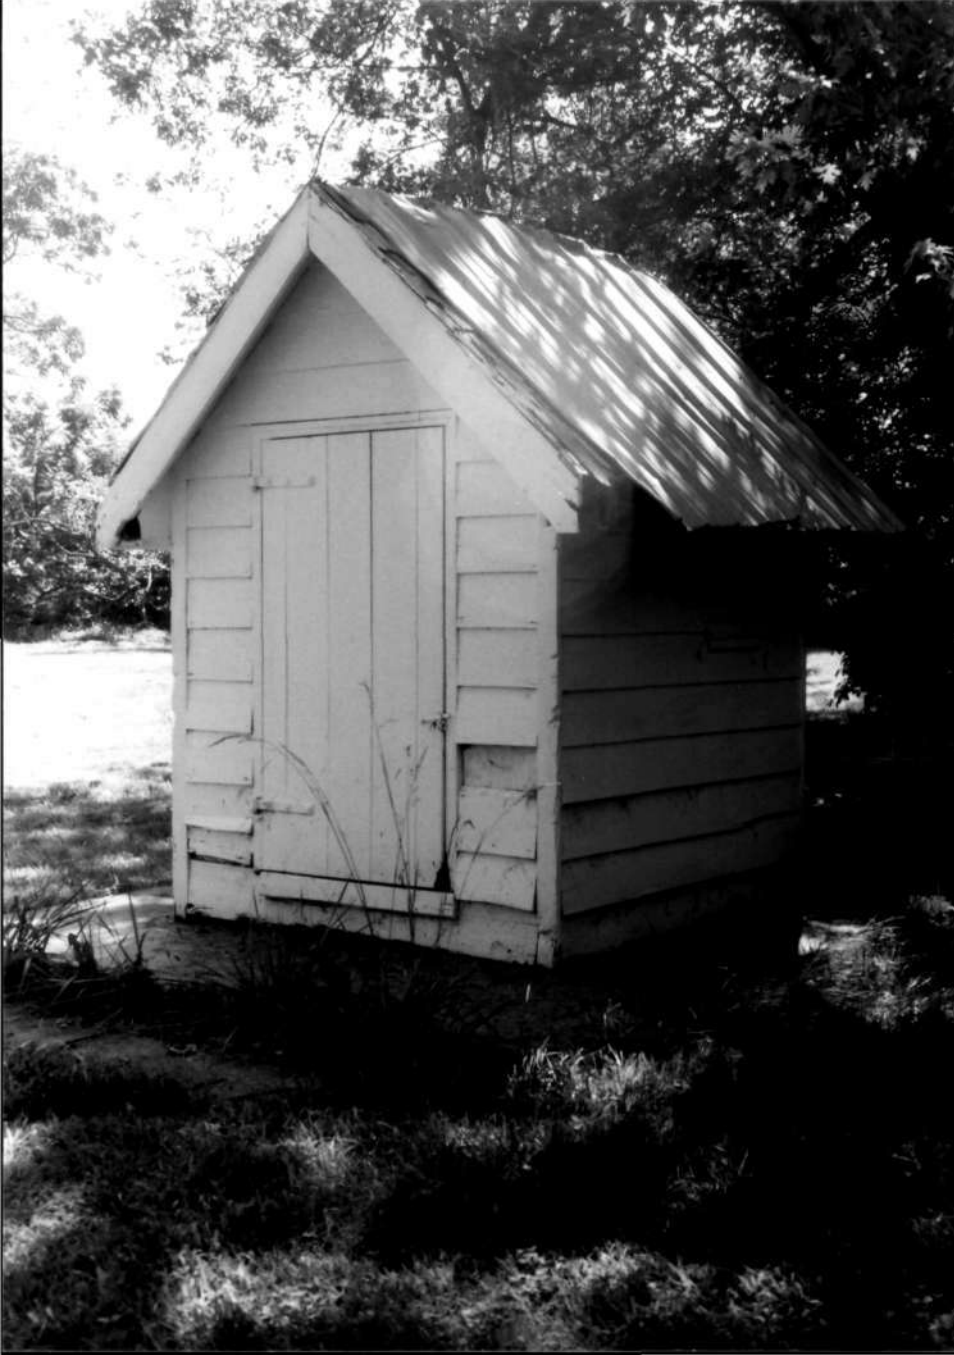
3/25

SMOKEHOUSE looking III

A wood frame smokehouse has been moved onto a concrete pad at the rear of the tenant house. The smokehouse is clad with vertical wood siding and has a front-gable roof clad with standing-seam metal over wood shingles. The building is entered through a hinged wood plank door on the west façade. There are no windows.

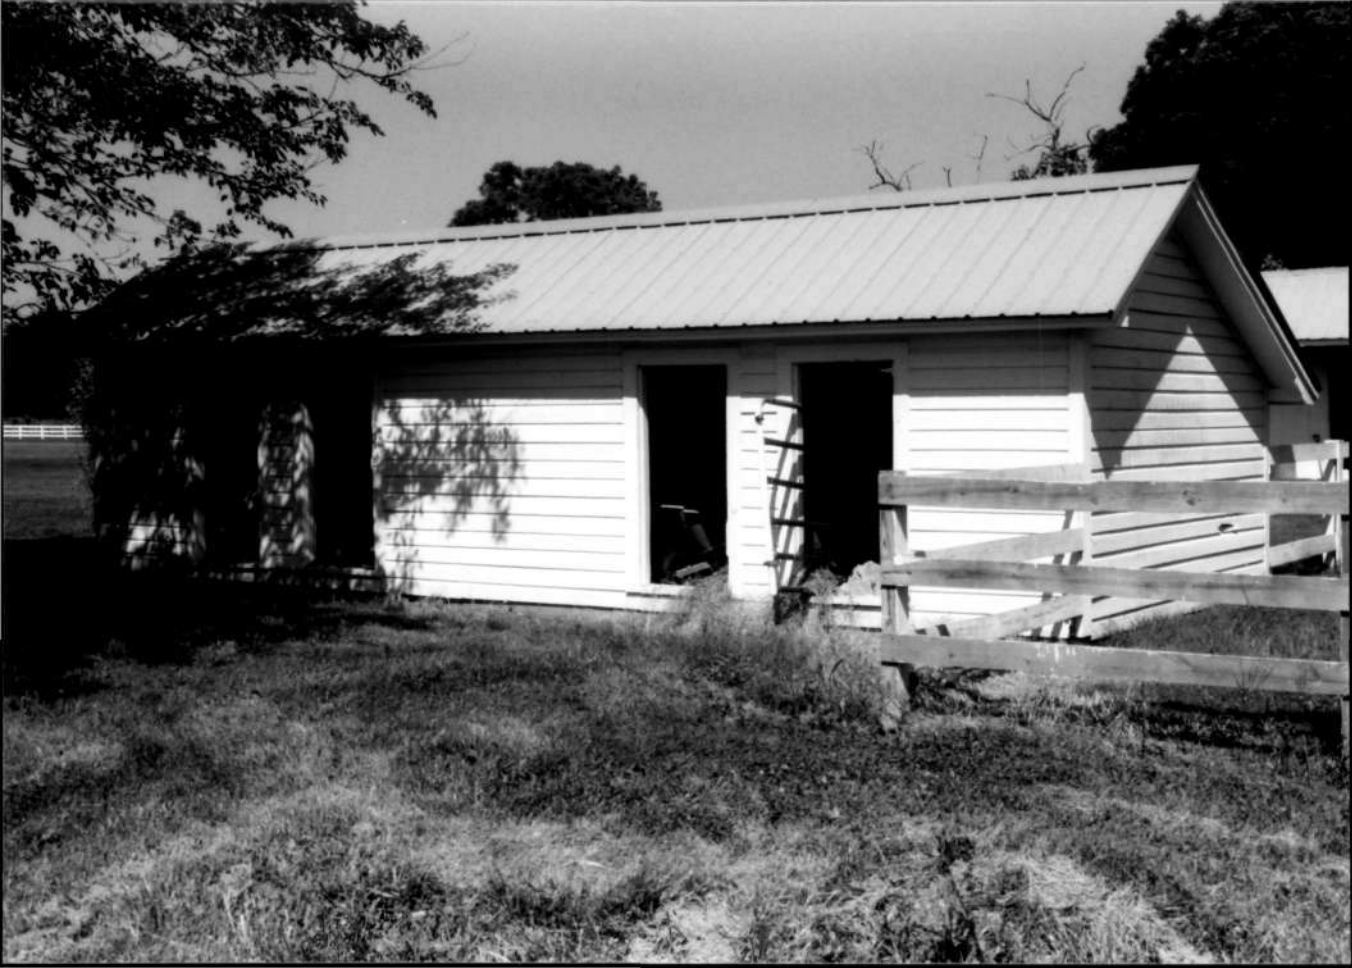
16/25

hog house looking W

The ca. 1935 hog house is located closest to the dairy barn and is a one-story light timber frame structure. The interior is divided into three rooms, one of which is an internal corn crib. A one room side addition has been constructed on the north façade. The building rests on a poured concrete slab with a one-foot curb around the perimeter. The walls are clad with beveled wood siding. The walls of the corn crib portion of the building are clad with three-foot wood planks, spaced approximately one-half-inch apart. The offset side gable roof is clad with standing-seam metal. Four exterior doors on the east and south façades are hinged plywood panels and one exterior door and the two interior doors are hinged five-panel wood. The majority of the window openings have been boarded up. Nine-pane wood awning sash windows are located on the west and south façades. The horizontal openings which flank the central entry doors on the east façade have been left open, with a single one-over-one horizontal vinyl sash used as infill. The building has an interior concrete masonry unit chimney, which is not visible on the interior. The interior of the building is unfinished with a poured concrete floor. The walls are clad with a combination of beadboard and wood planks. The ceiling is clad with the same beadboard.

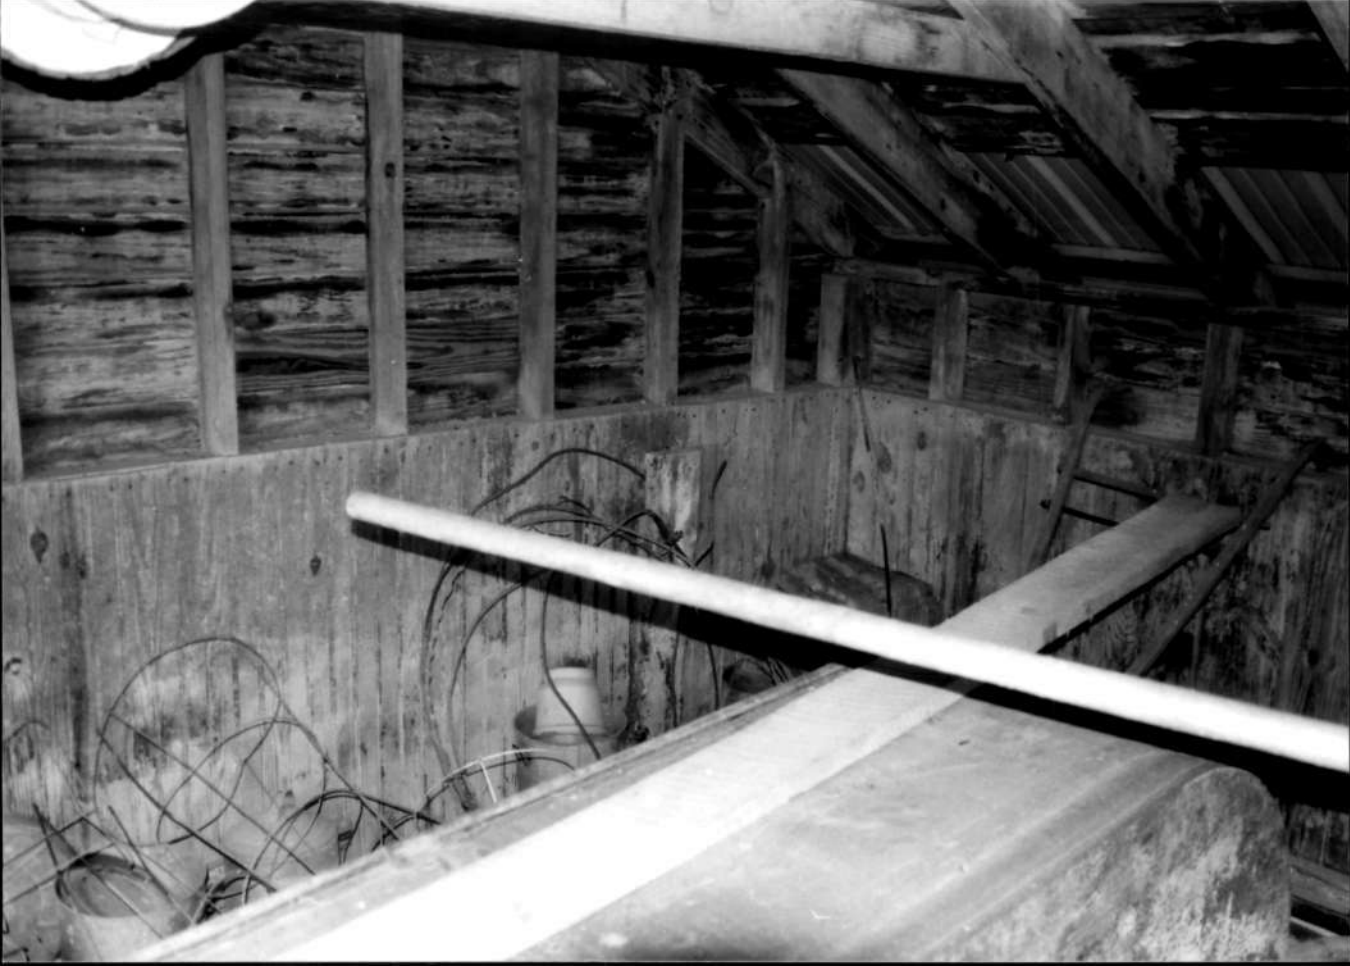
7/25

INTERIOR Hog house looking SW

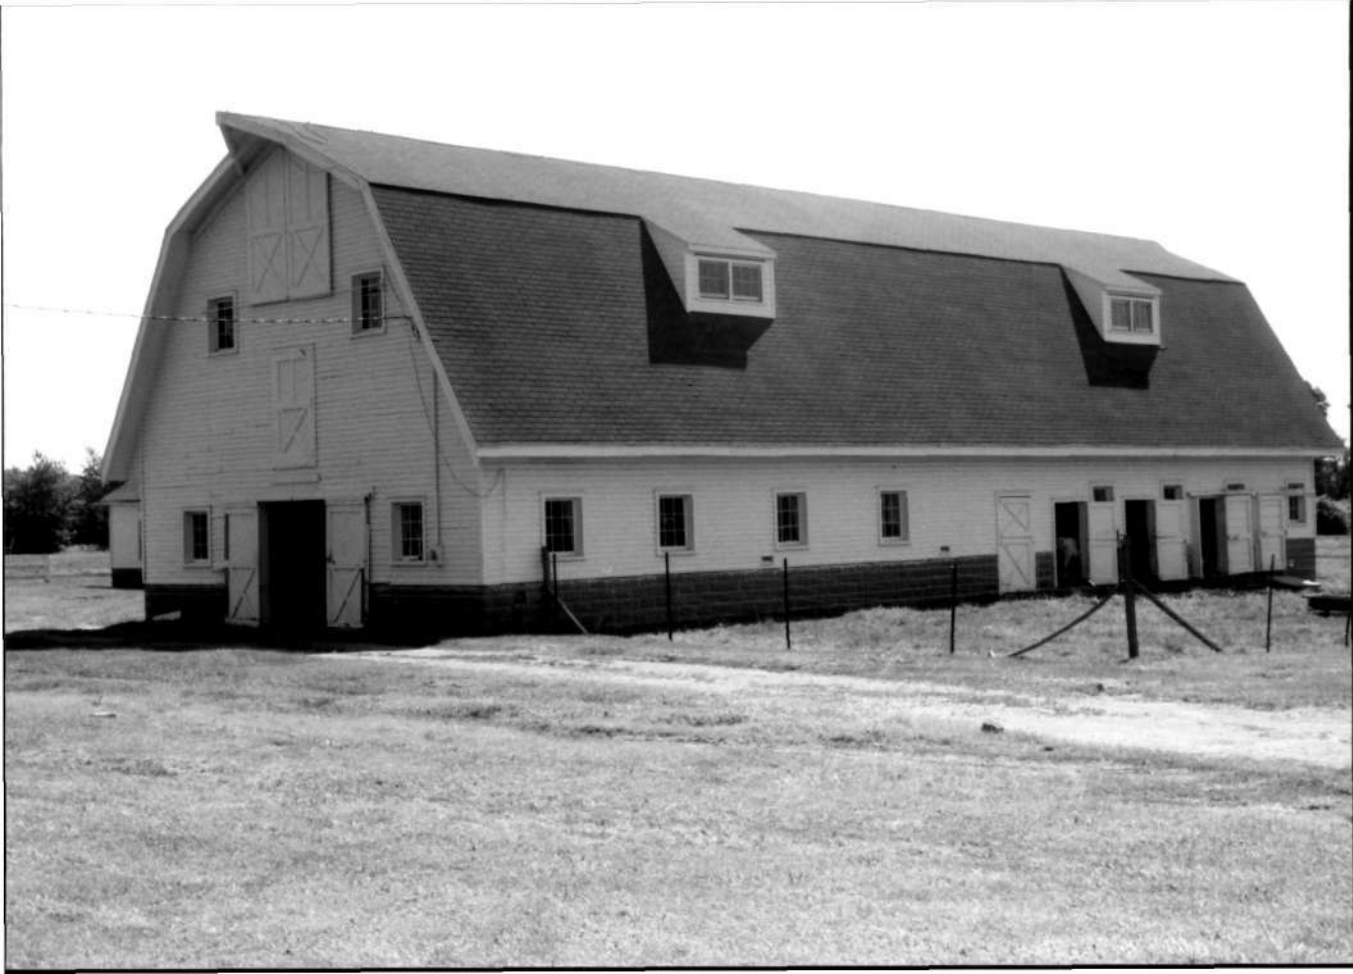
11/25

Dairy barn looking E

The main building of the complex is the gambrel-roofed dairy barn, built ca. 1935. The barn is a two-story timber frame structure with a poured concrete slab foundation. The building is eight bays deep and has a center aisle plan with a hayloft on the second level. The gambrel roof is clad with asphalt shingles and has hay hoods on either end and four shed roof dormers. Two dormers with paired six-pane wood awning sash windows are located on each side of the roof. Eight lightning rods are located along the roof ridge.

The main building entries are located on the east and west gable ends. The gable ends have rusticated rock-faced concrete masonry units forming the lower two-and-a-half feet of the wall. The upper portion of the wall is clad with beveled wood siding. The building is entered through a central set of sliding wood plank doors with diagonal bracing. The doors are flanked by nine-pane wood awning sash windows. Two sets of hinged hayloft doors are located on the west façade. The lower door is constructed of wood planks with diagonal bracing. The upper set of doors is also constructed of wood planks with diagonal bracing. Two nine-pane wood awning sash windows are located between the hay loft doors.

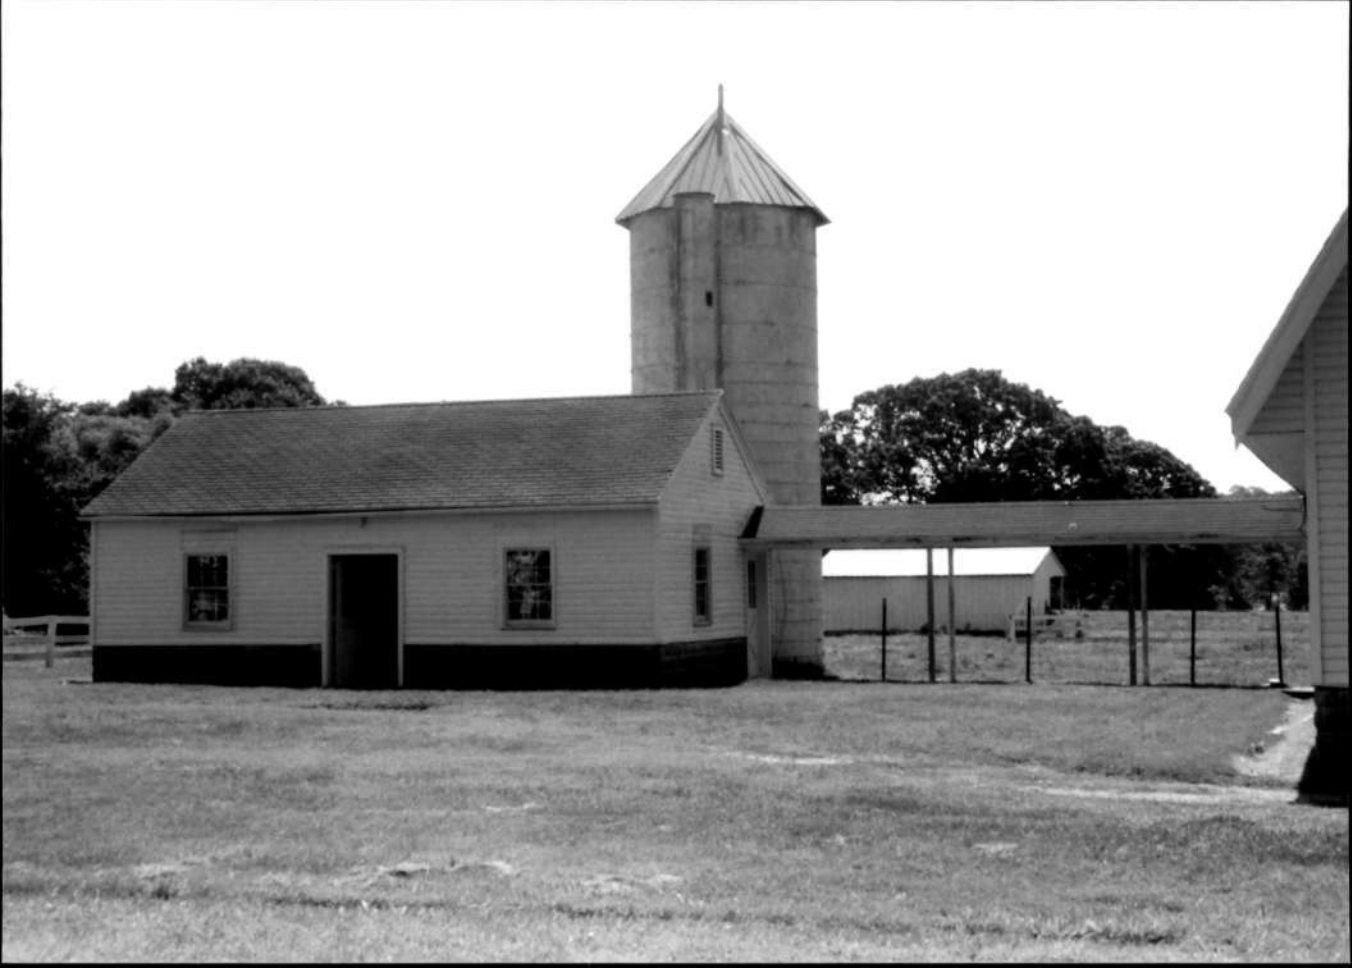
13/25

Milkhouse + breezeway looking S

Located adjacent to the dairy barn to the northeast is the milk house which is connected to the barn via a covered gable roof walkway with four steel columns and a poured concrete floor. The ca. 1935 milk house is a one-story light timber frame structure with an undivided interior space. The building rests on a poured concrete slab. Rusticated rock-faced concrete masonry units form the lower two-and-a-half feet of the walls. The upper portions of the walls are clad with beveled wood siding. The side gable roof is clad with asphalt shingles. The doors on the south gable end and west side wall are hinged wood plank doors with diagonal bracing and eight lights. The original windows have been replaced with one-over-one wood and six-over-six vinyl sashes which are smaller than the original windows. The interior of the building is unfinished with a poured concrete floor. The bottom three feet of the wall are clad with three inch horizontal tongue and groove beadboard.

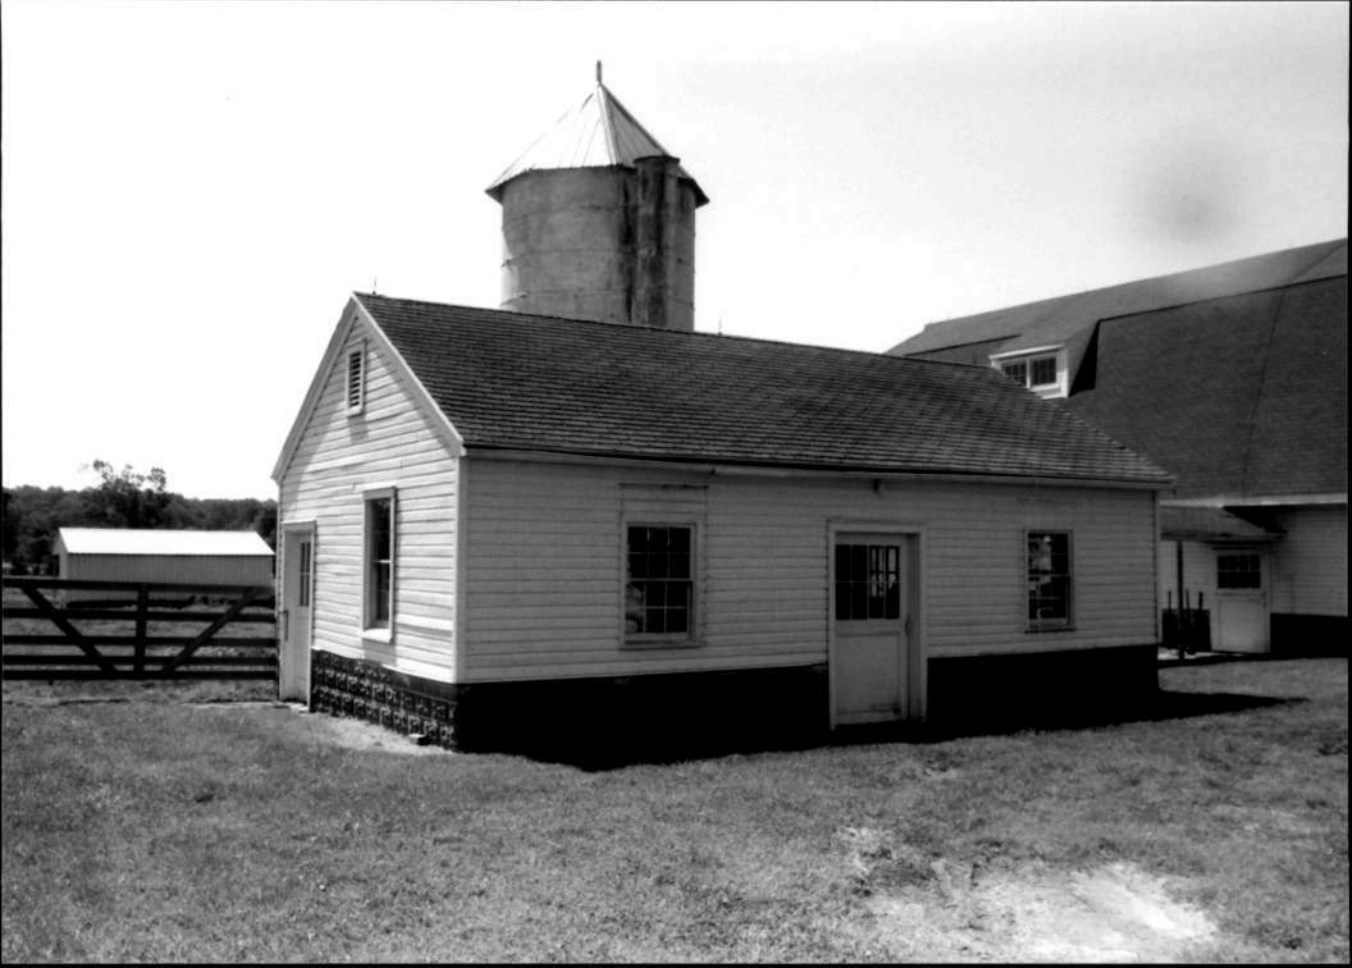
14/25

Milkhouse + breezeway looking S

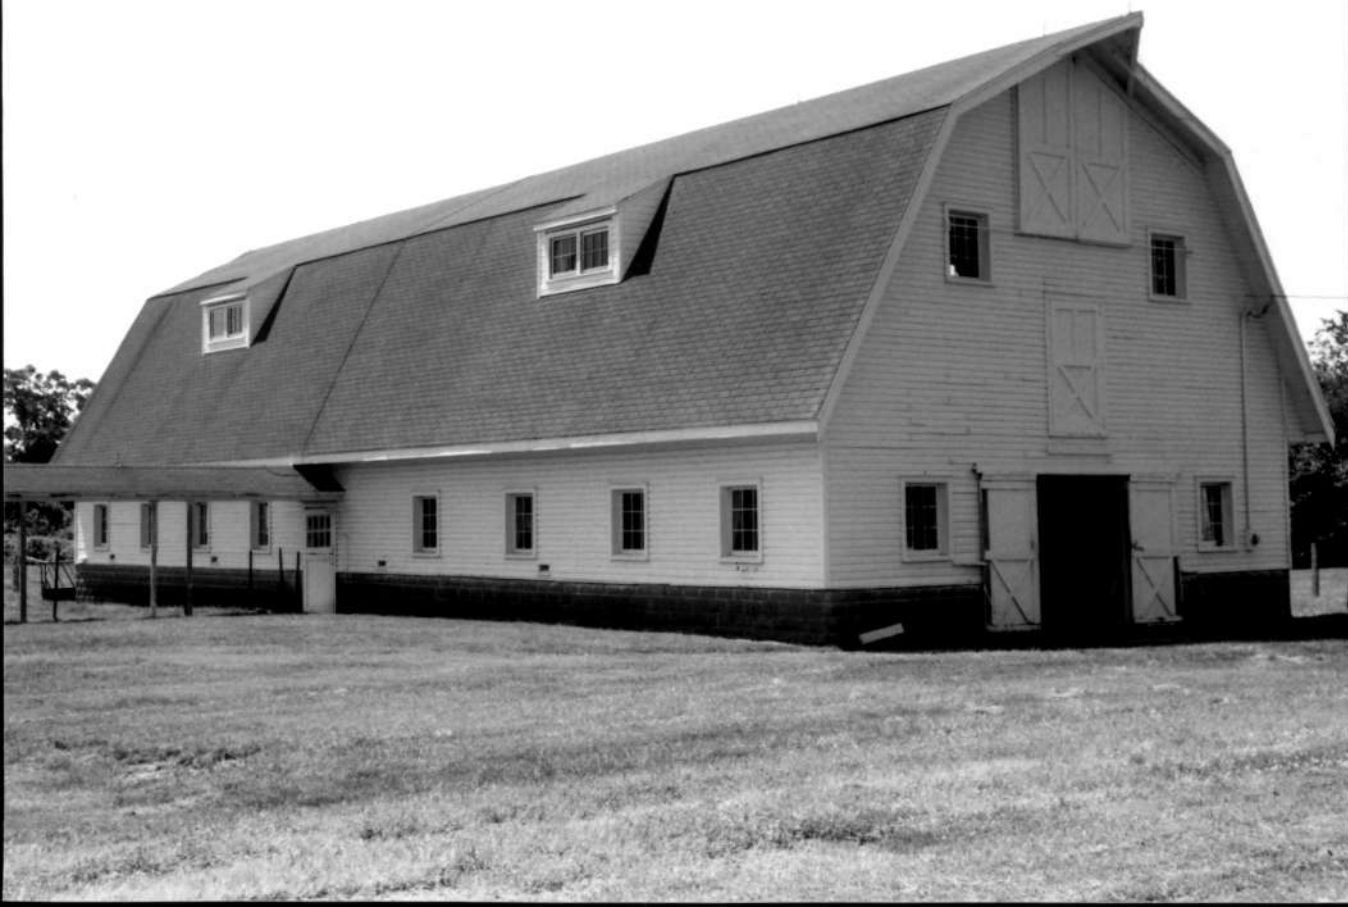
17/25

DAIRY BARN looking S

The side walls have rusticated rock-faced concrete masonry units forming the lower two-and-a-half feet of the wall. The upper portion of the wall is clad with beveled wood siding. The south elevation has five Dutch doors on the eastern half of the wall constructed of wood planks with diagonal bracing with nine-pane wood awning sash windows located to the right of the four eastern-most doors. The two eastern most doors have been converted into sliding doors. Four evenly spaced nine-pane wood awning sash windows are located along the western half of the wall. The north façade has a central hinged wood plank door with diagonal bracing and 8 lights. The door leads to the adjacent milk house, which is connected to the barn via a covered walkway. Four evenly spaced nine-pane wood awning sash windows are located on either side of the doorway.

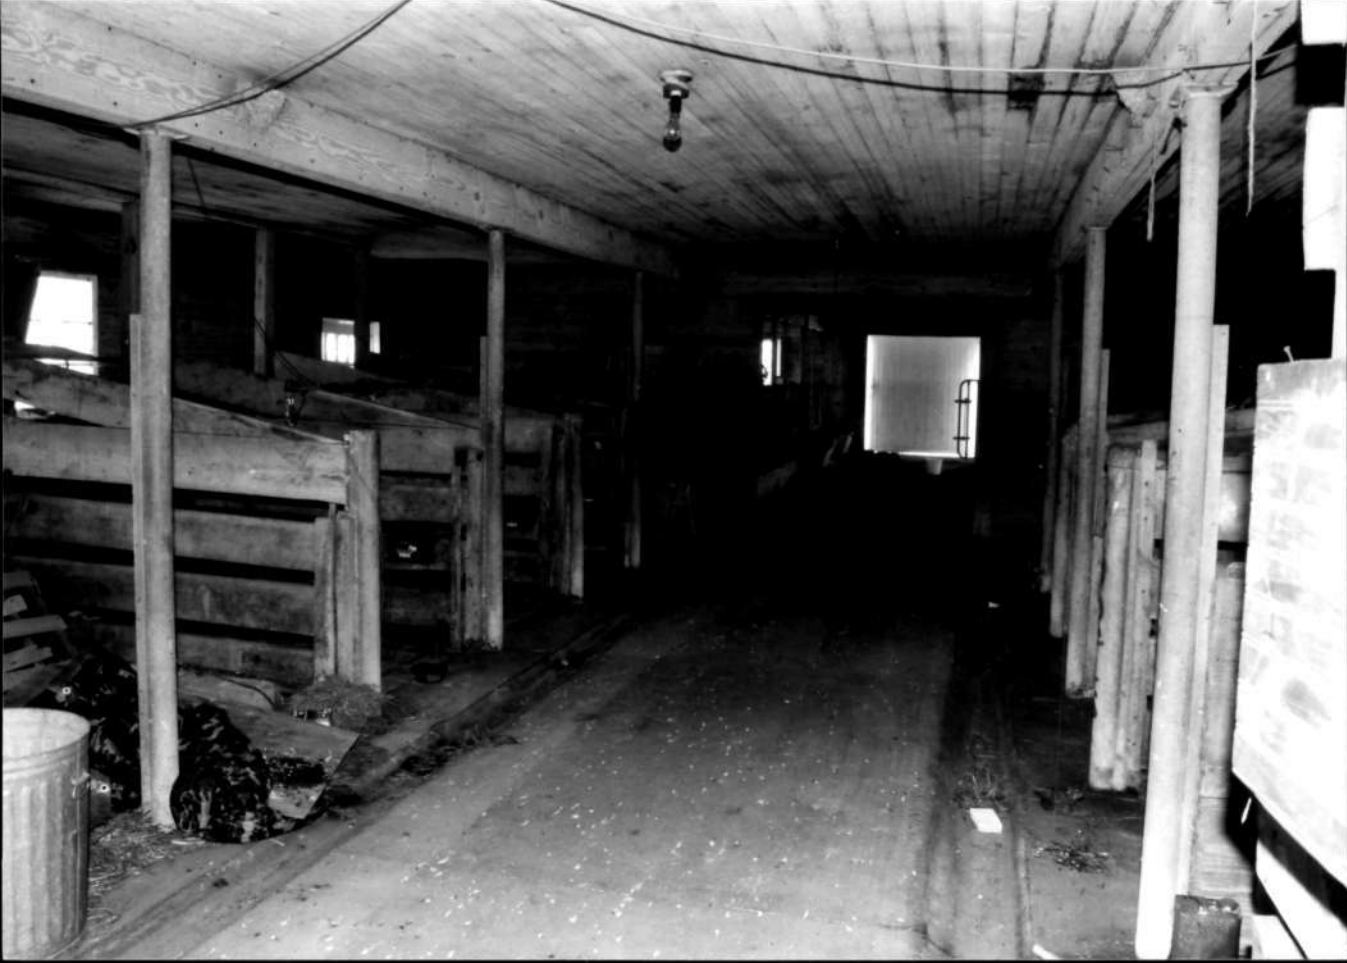
18/25

DAIRY BARN - INSIDE showing stalls  
look

The interior of the building is unfinished with a poured concrete floor. The lower two-and-a-half feet of the wall is constructed of the smooth rear face of the exterior rusticated, rock-faced concrete masonry units. The upper portion of the wall is clad with three inch horizontal tongue and groove beadboard. The ceiling of the first floor is clad with the same beadboard. The twelve interior columns are of steel. The first floor is evenly divided into two spaces by a timber frame wall with a sliding wood plank door with diagonal bracing. Two storage rooms are located in the northeast and northwest corners of the western half. The eight stalls in this portion of the building are of wood plank construction. The stalls in the eastern half of the building have been replaced with tubular steel stanchions. The second floor hayloft is an undivided space accessed via a wood ladder. The space is unfinished, with a wood plank floor and exposed trusses and framing.

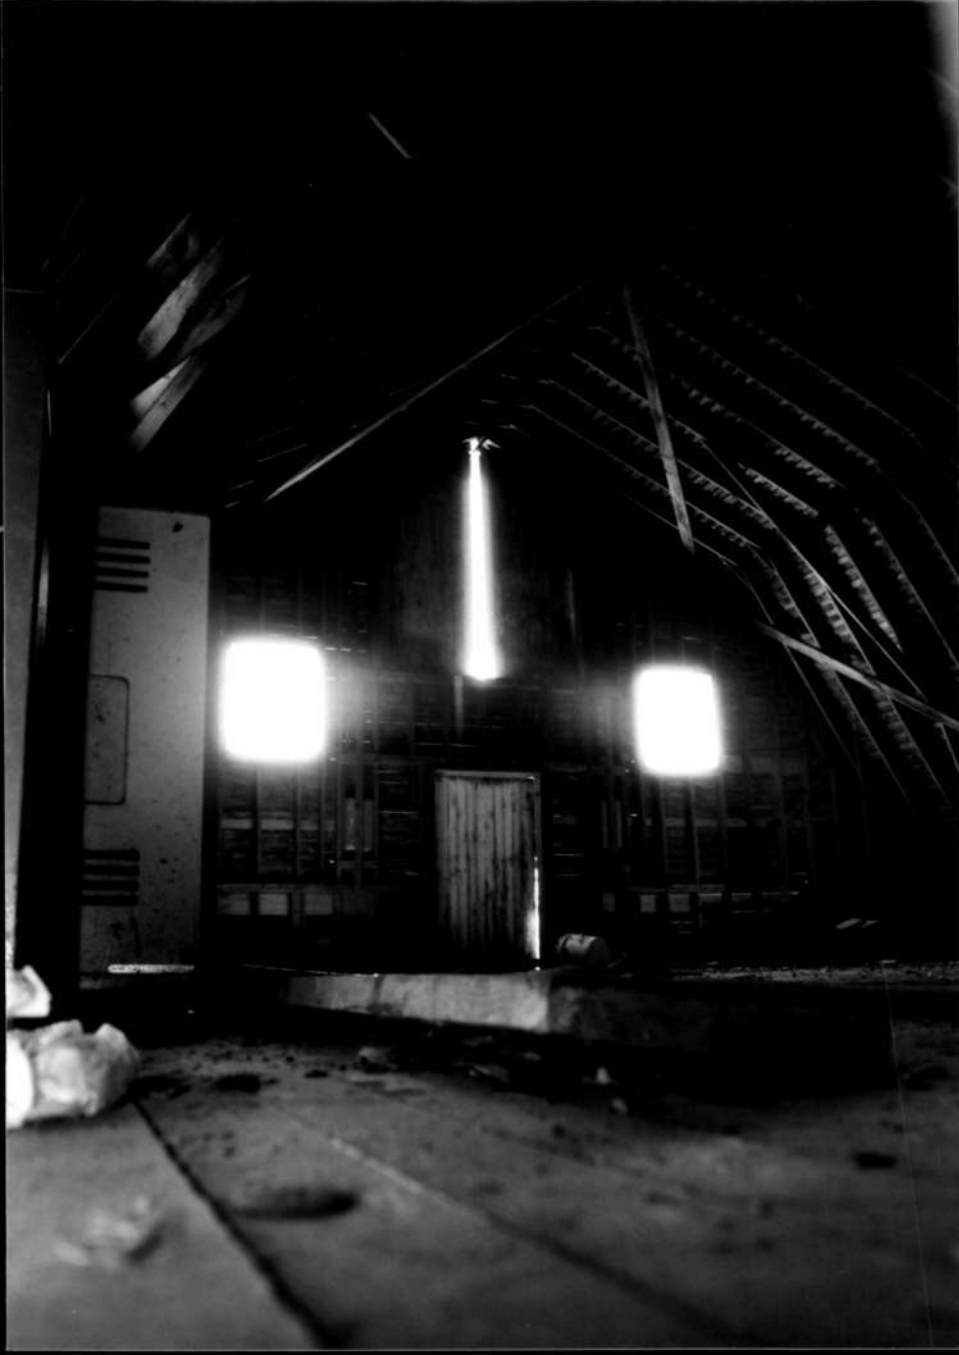
19/25

Dairy barn with little space showing rafters  
looking E

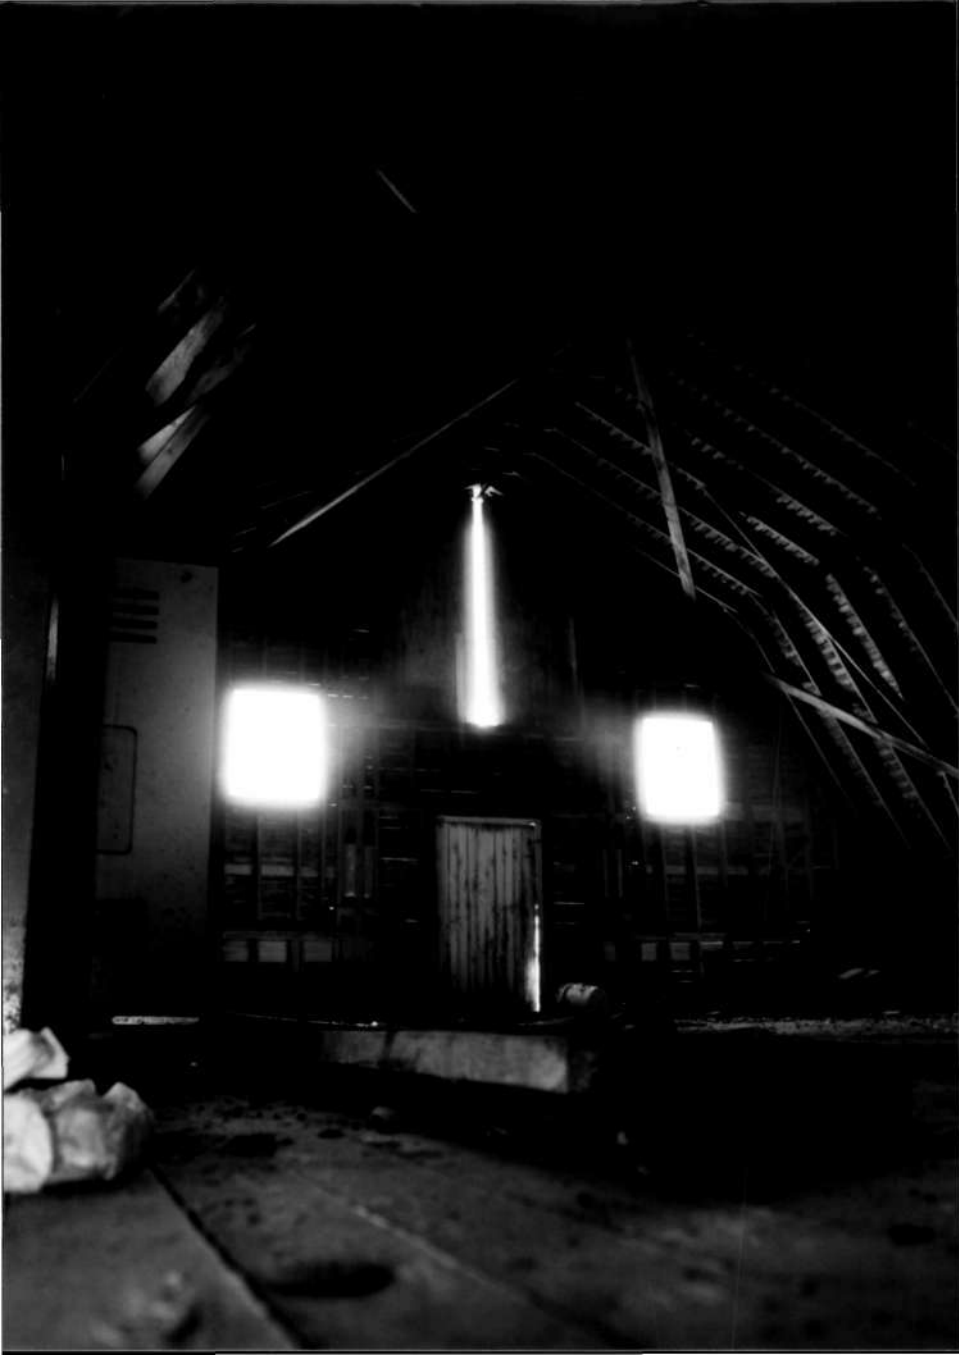
20/25

Dairy barn with space showing table ends

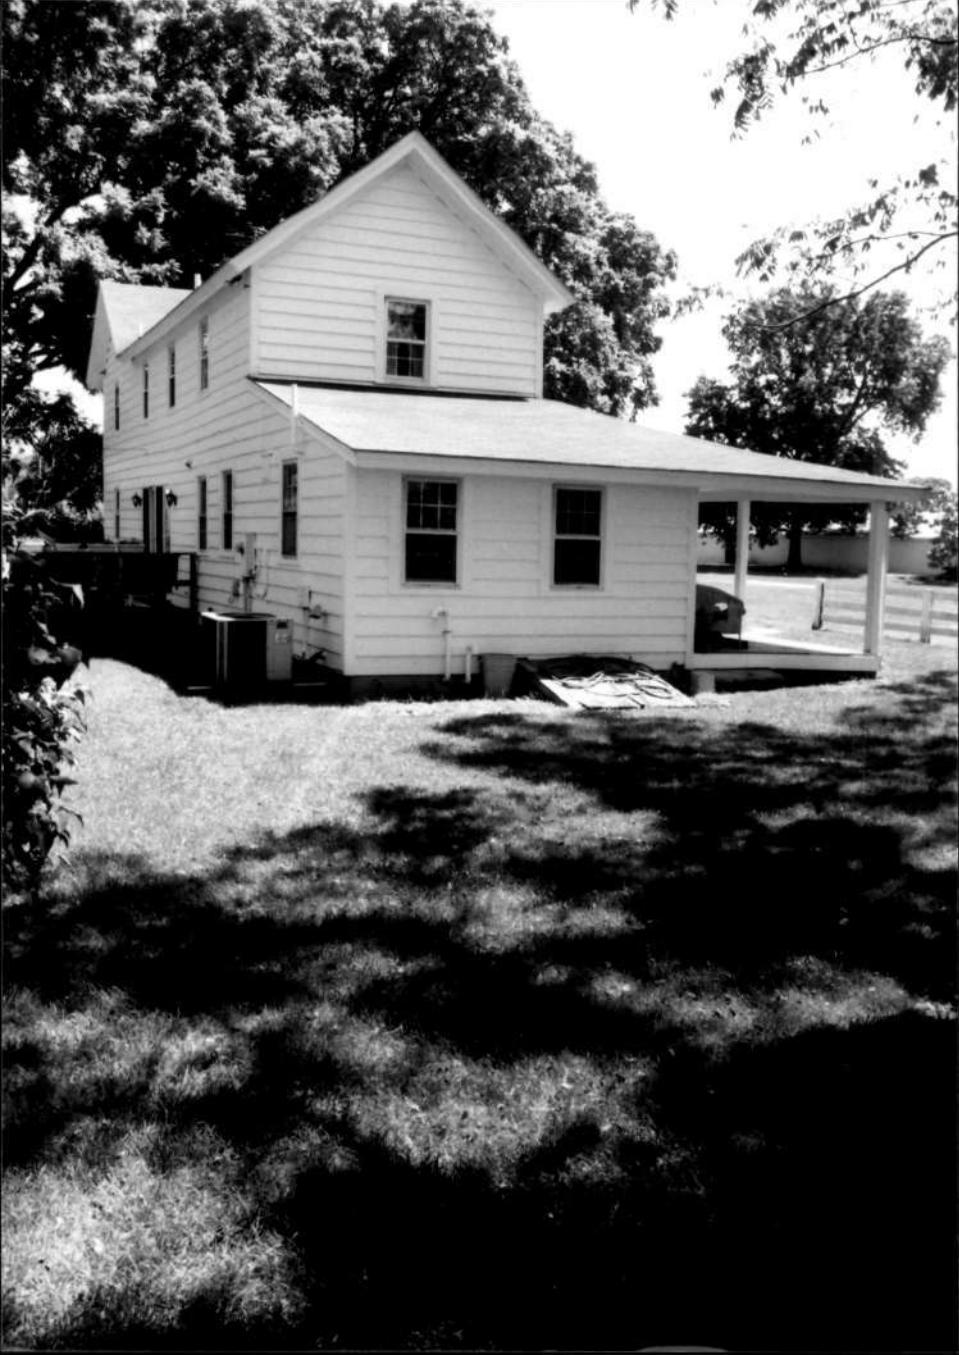
23/25

Tenant house (rear view) looking

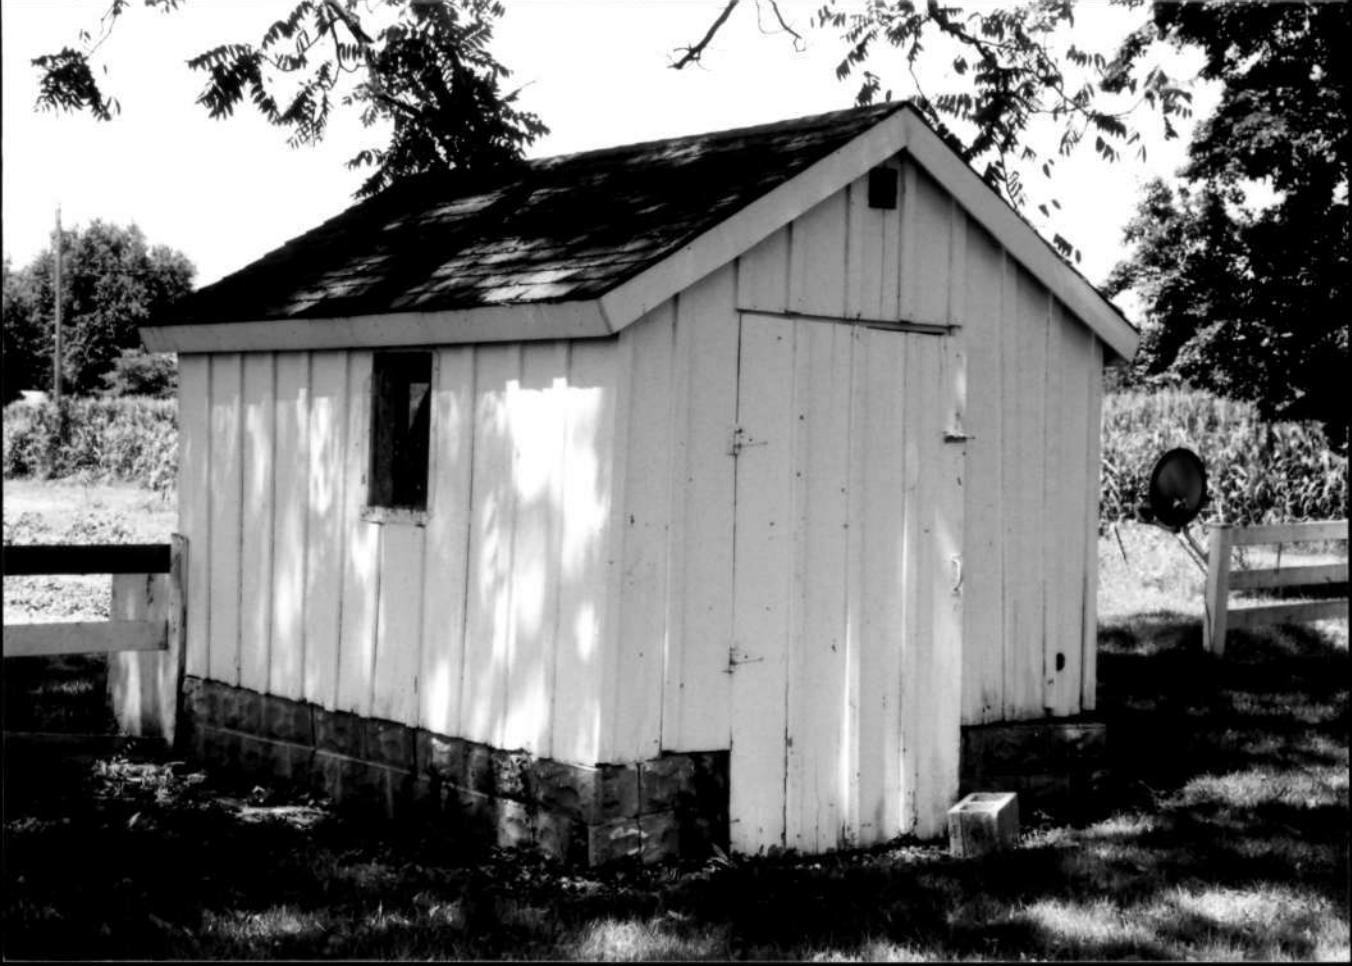
24/25

STORAGE SHED looking W
